ELEVATED ALPHA SURFACE ACTIVITY ON PIER COMPONENTS

Issue: Elevated alpha activity has been reported on various pier components such as bollards, cleats, and concrete with traces of weathered paint likely containing zinc. These pier components may need to be remediated and disposed of as low-level radioactive waste (LLRW) if the current reference background materials are used during the survey process. Note that this is an issue across all pier locations at Hunters Point Naval Shipyard (NPNS), potentially including areas where radiological free release has already been granted by the regulatory authorities.

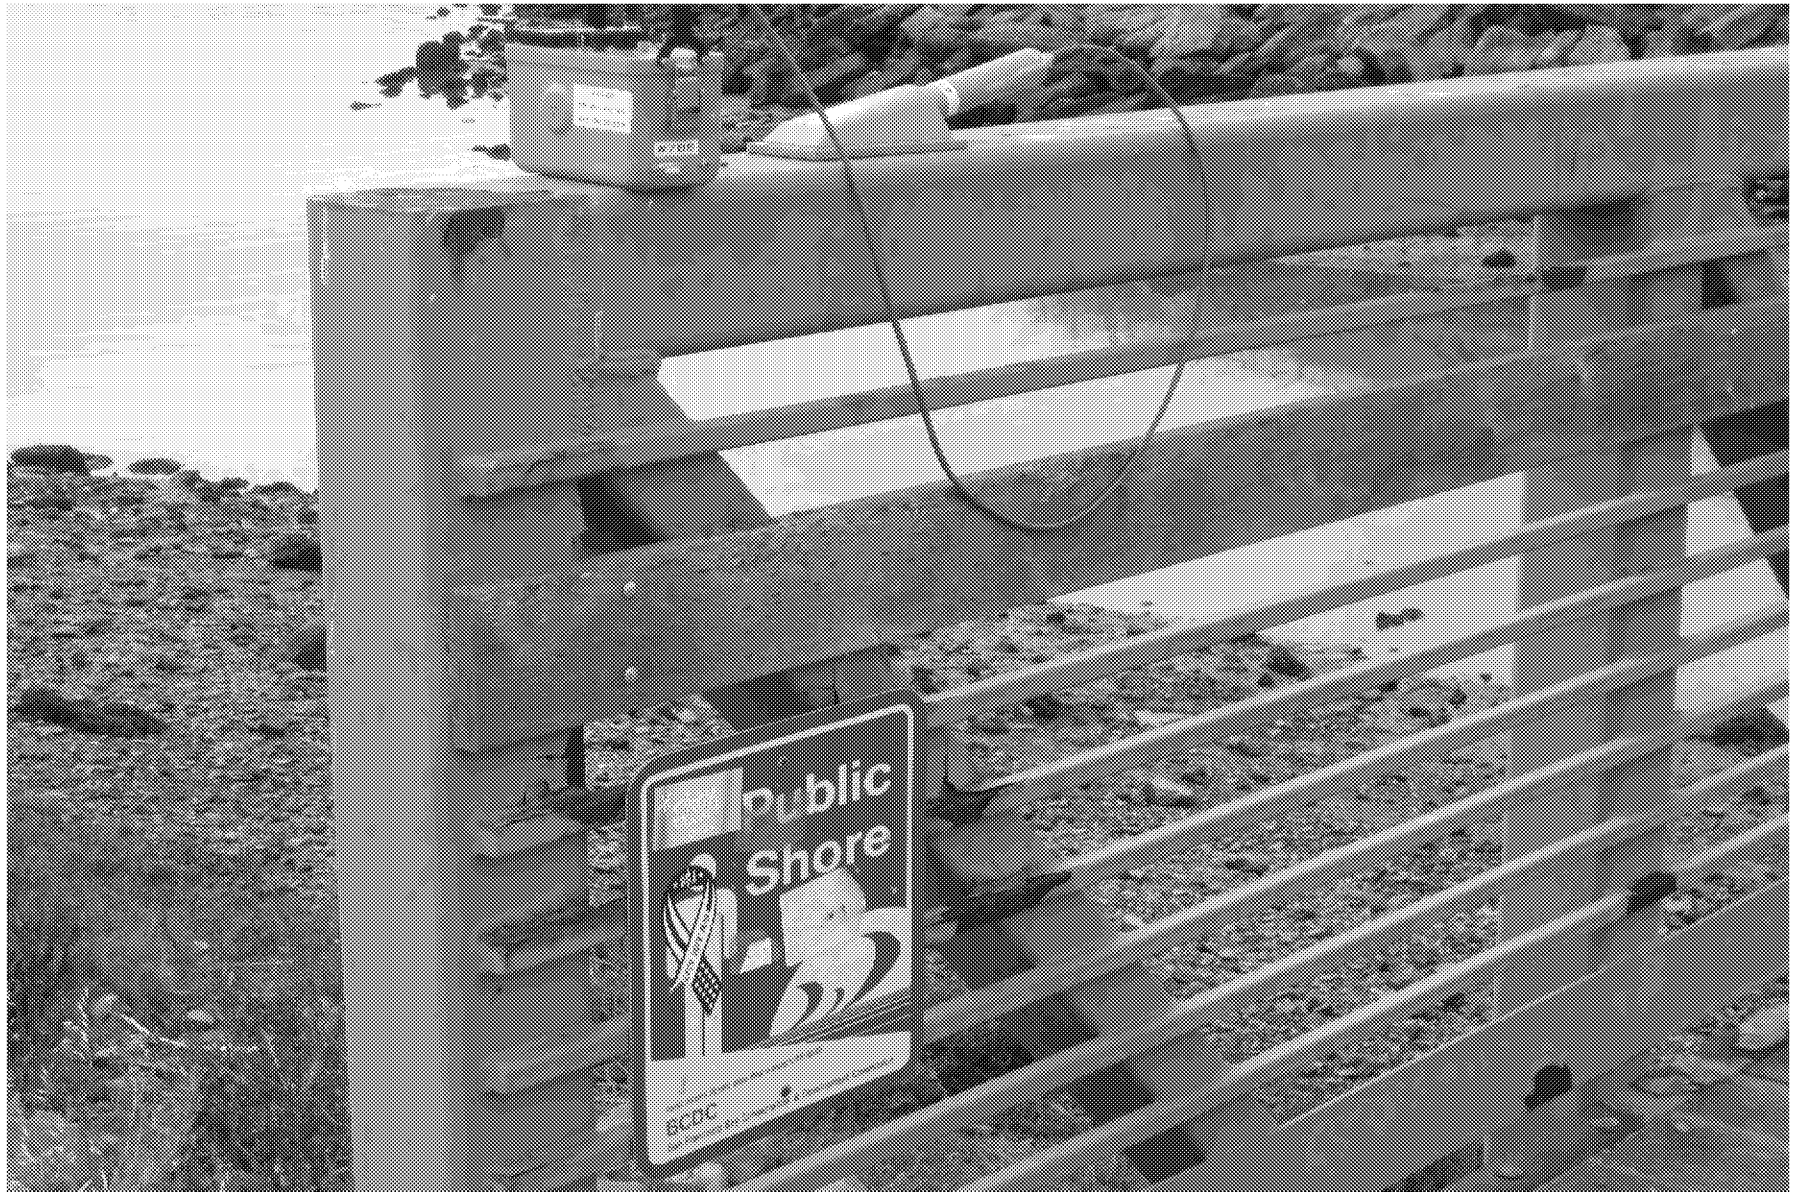
Photo #220 – Herrons Head Park Bridge Rail

Location	Photo #	Gross Alpha CPM	Gross Beta CPM	Alpha BKG	Beta BKG
Herrons Head Park bridge rail painted	220	2	163	1	219
Herrons Head Park bridge rail unpainted	220	3	125	1	219
Herrons Head Park plate ramp to bridge	221	4	144	1	219
Herrons Head Park alum. lookout tower	222	8	120	1	219
Herrons Head Park alum. lookout tower loc. #2	223	7	155	1	219
Herrons Head Park concrete pad @ lookout	N/A	3	209	1	219
Pier 50 repair facility bollard on pallet right nub	225	17	148	1	219
Pier 50 repair facility bollard on pallet left nub	225	21	139	1	219
USS Cape Hudson mooring cleat pier 48	N/A	17	144	1	219
HPNS Bollard E/W at N. side DD #4	226	7	129	1	219
HPNS Pole #2 B-206, top of pole cap	227	27	191	1	219
HPNS Pole #2 B-206, side of pole	227	6	138	1	219
HPNS Capsan tip of DD #2 top	228	11	194	1	219
HPNS Capson tip of DD #2 side	228	5	177	1	219
HPNS Bollard N. side DD #2 top	229	18	188	1	219
HPNS Bollard N. side DD #2 side	229	5	154	1	219
